National Register of Historic Places
Registration Form

historic name Koons, Jacob, Farm

other names CARR-113

The Jacob Koons Farm is located at 1151 Otterdale Mill Road, about 3-1/2 miles south of Taneytown, about 2-1/2 miles north of Union Bridge, and close to 3 miles northwest of Uniontown in northwestern Carroll County, Maryland. The farm is located on the east side of Otterdale Mill Road, with the house facing west towards the road. The farm sits on a generally flat or slightly undulating site, and the farm complex consists of a stone house, a stone smokehouse, a frame summer kitchen, a frame bank barn, a frame privy, several sheds and two prefabricated metal buildings. According to the owner, there once was a wire metal fence and gate enclosing the yard in front of the house that replaced the picket fence seen in a historic photo.

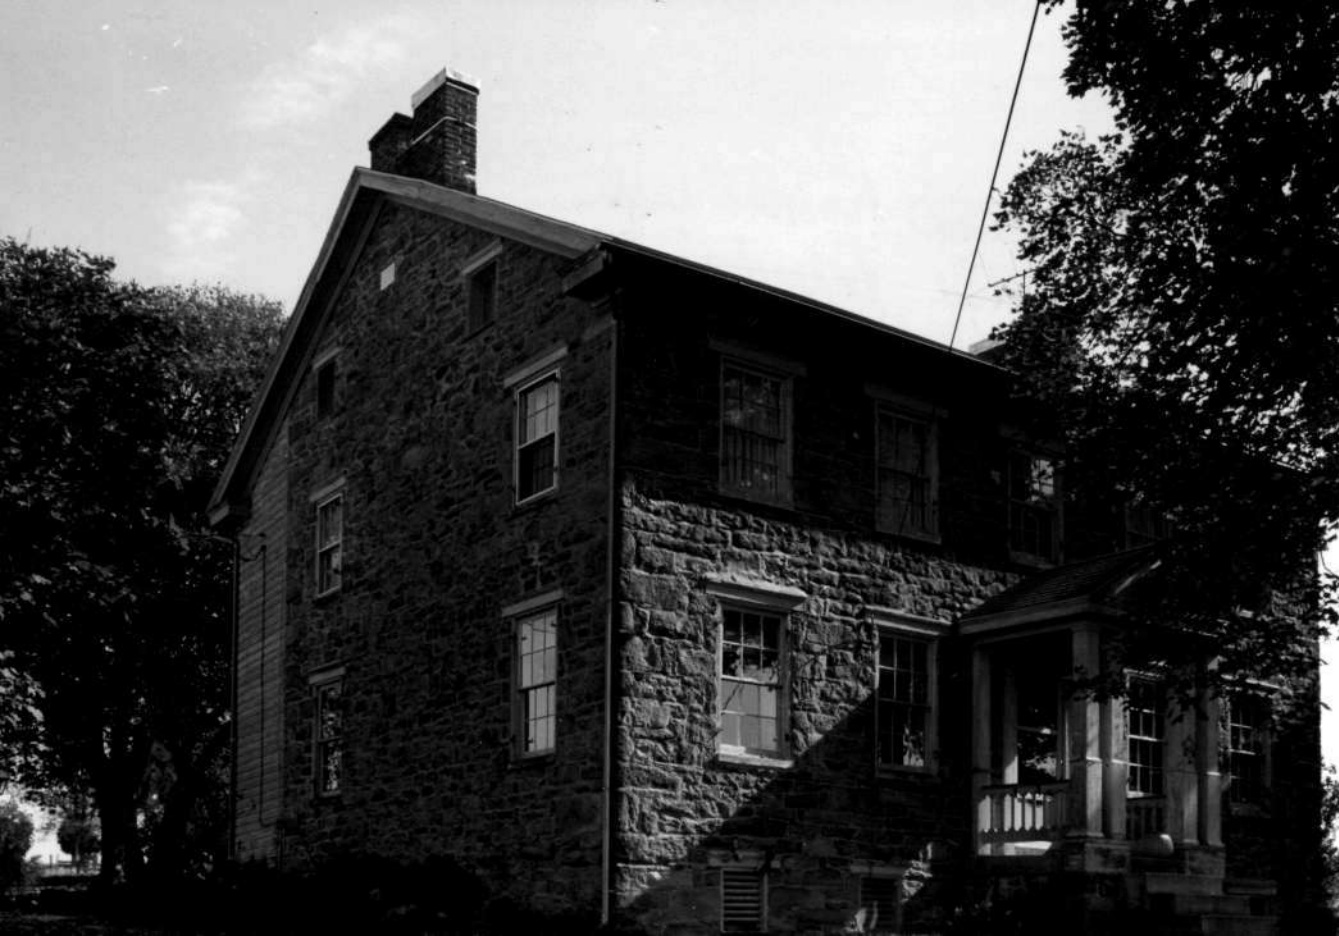
2/16

Jacob Koops Farm
1151 Otterdale Hill Rd
House - N & W Elevs
Carroll County Maryland
Photo: Kenneth M. Short

The property is accessed by a driveway off Otterdale Mill Road. A **concrete slab bridge** carries the driveway across Cabin Branch. The **house**, constructed in 1869, is a five bay by two bay, two story rubble stone structure with quoining at the corners. It has a gable roof of asphalt shingles with a north-south ridge. On each gable end are interior double brick chimneys. In the foundation the north and north-center bays have diamond-in-section wood louvers set in beaded-interior-edge mitered frames. They have thin wood sills, wood lintels with quirked Greek ogee cornice moulds, and six-light sash set behind them. The center bay has a rubble stone porch foundation, with a concrete deck and brick piers under the front posts. The south-center and south bays each have a six-light sash with the same frame sills and lintels as the north bay openings.

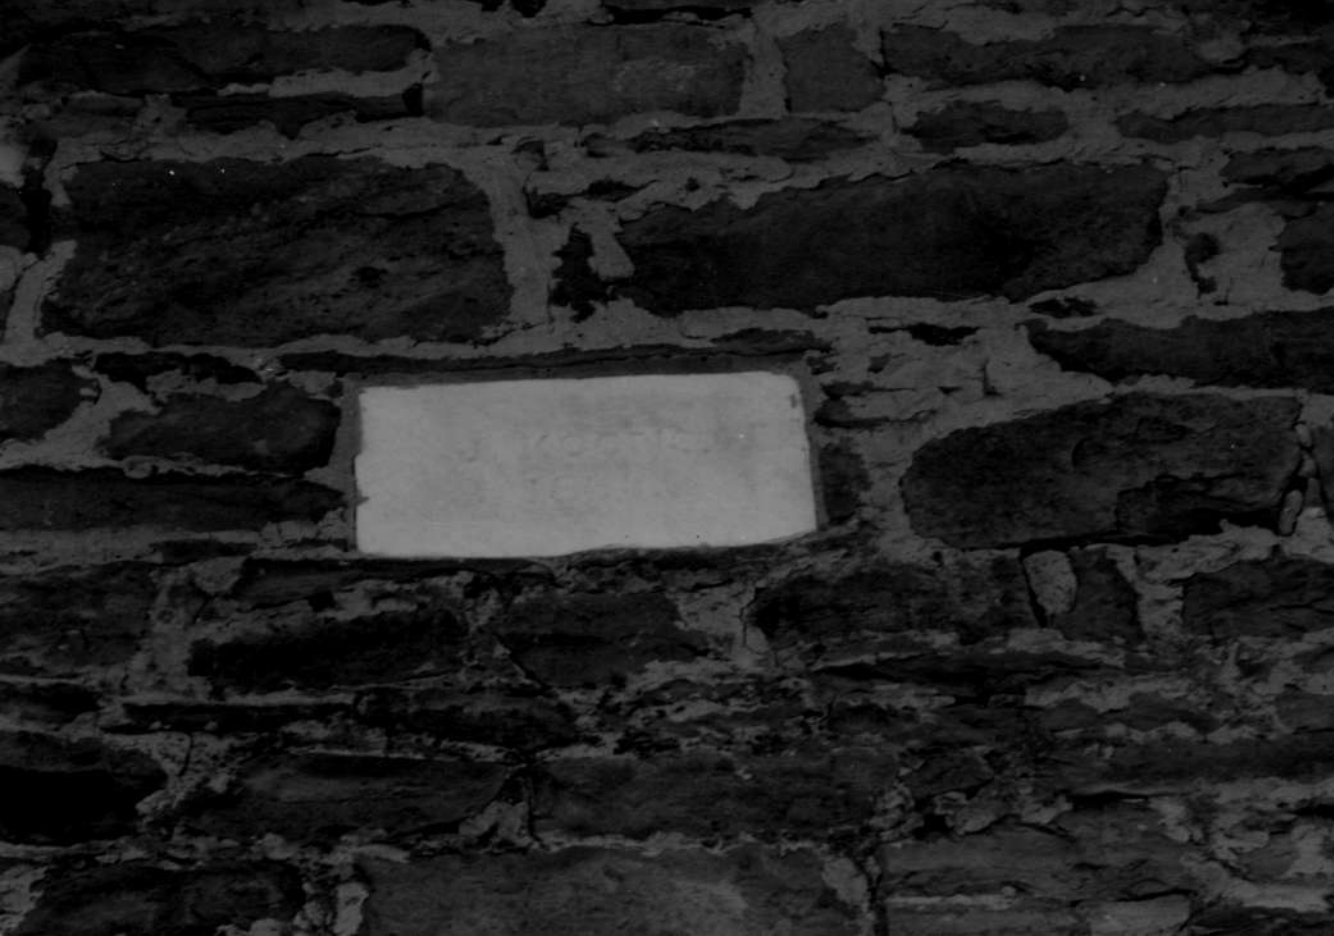
Jacob Koons Farm
1151 Otterdale Mill Rd
House - N elev Date Stone
Carroll County Maryland
Photo: Kenneth M. Short
Date: Oct 97
Neg Loc. Maryland Historical Trust
3/16

stories each have two typical 6 over 6 sash, the gable end has two four-light casements, with typical frames and lintels and thin wood sills. Between the windows is a marble date stone chiseled with "J. KOONS 1869." The raking eave cornice also has a paneled soffit. The porch on the east elevation is set under the symmetrical gable of the house and has the same cornice. The north end of the porch has German siding on both the first and second stories.

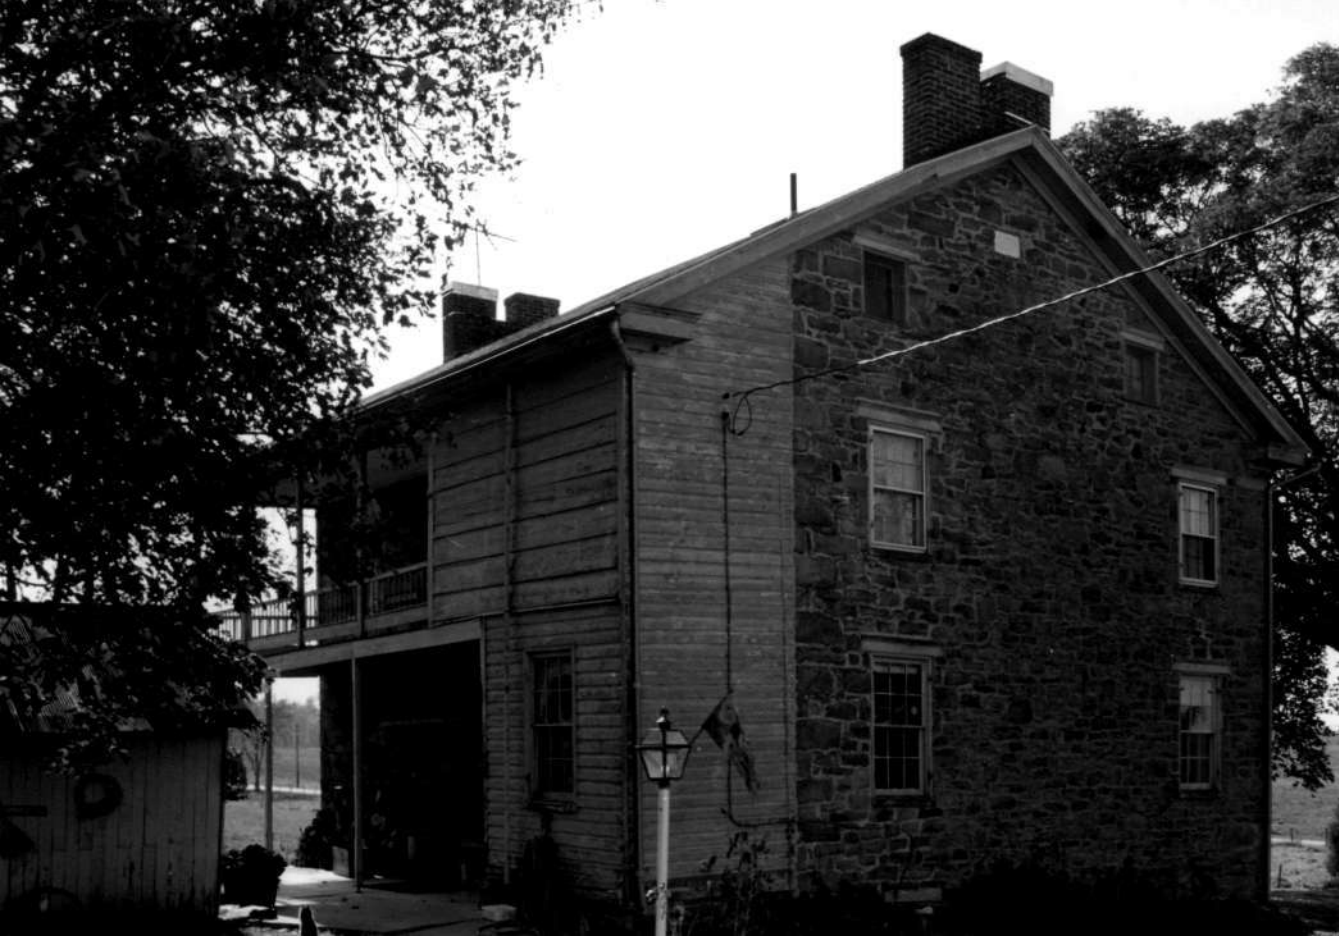
Neg Loc. Maryland Historical Trust
4/16

Jacob Koons - Farm
1151 Otterdale Mill Rd
House E & N Elevs

The first story of the east elevation has no openings in the south and the south-center bays. The central bay has a typical 6 over 6 sash and the north-center bay has a four-panel door that has sunk fields and beveled panel moulds. There is an eight-light transom with a plain transom bar. The jambs have one-panel at the door and another panel at the transom on each side. There is also a single panel on the soffit. The panels are sunk and flat and have beveled panel moulds. The north bay has an enclosed porch with German siding fastened with cut nails. It has a typical 6 over 6 sash with no lintel. The south elevation of this enclosure has German siding and infill of German siding where a door formerly stood. There is a two story porch on this elevation that has three chamfered posts on the first story and corrugated metal on the soffit of the porch. On the second story the porch has seven chamfered posts with square balusters over a horizontal board rail. There is weatherboarding on the north center and north bays of the porch that covers the three northern most posts and two sections of railing. There is a tongue and grooved wood deck to the porch and corrugated metal on the soffit. The north and south bays on the second story have a typical 6 over 6 sash. There are no openings on the north-center and south-center bays. The center bay has a four-panel door with sunk fields and quirked ogee and bead mouldings. There is a 2-light transom with a plain transom bar. Each jamb has one-panel and there is one in the soffit. These are sunk flat panels with quirked Greek ovolo panel moulds. The doorway has a typical frame and lintel.

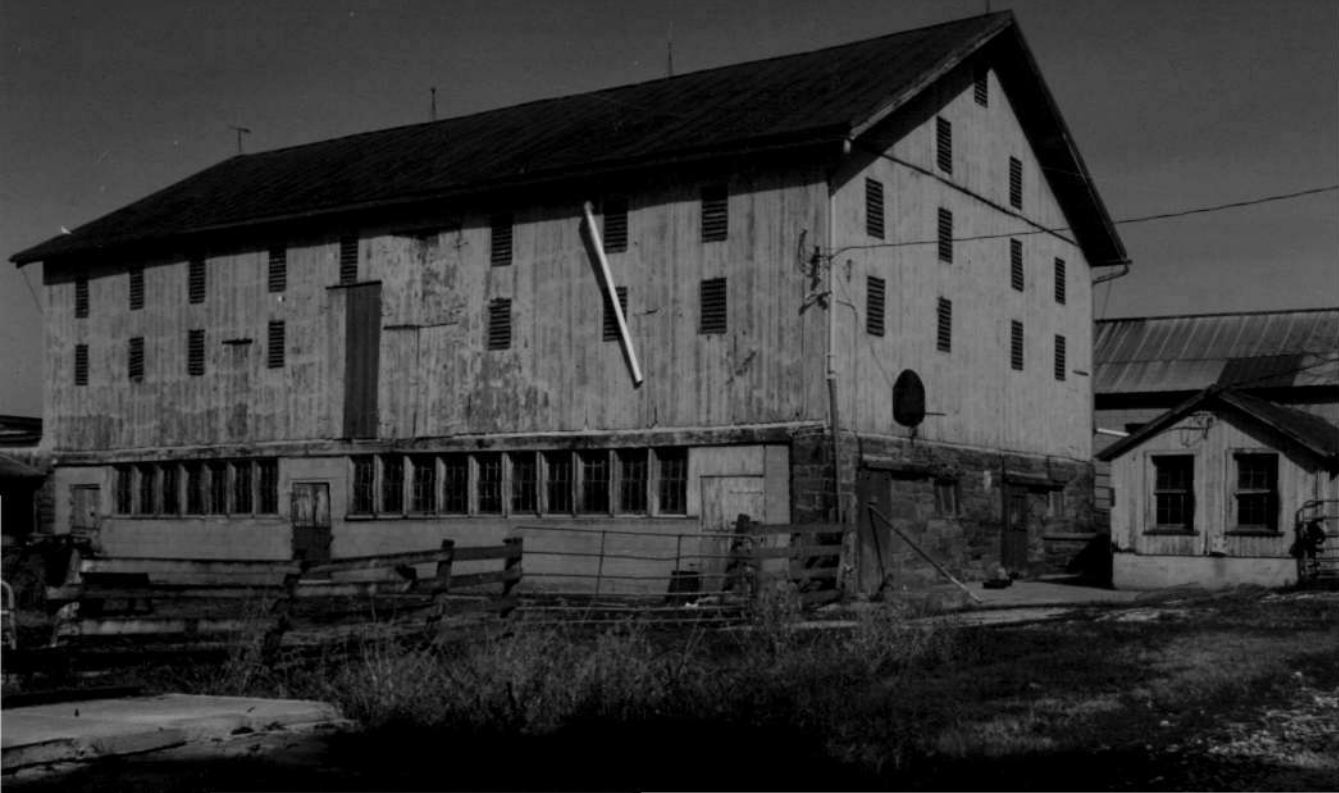
Neg Loc: Maryland Historical Trust
14/14.

Jacob Koons Farm
1151 Otterdale Mill Rd
Barn - W & S Elevs

The south elevation lower story has a rubble stone foundation wall that extends to the west end of the forebay. Beneath the forebay is a beaded-edge-and-center vertical board door hung on rollers with a two-light casement to the east of it, then an identical door and another two-light casement further east. The upper story has a vertical board door hung on butterfly hinges and set to the east. There are four wood louver vents with four more vents set above them. The gable end has two vents in the center and another above in the peak. The plates and purlins extend beyond the wall to support the eave and are tapered on the ends. There is a lightning rod-weather vane combination on the south end, another on the north, and two rods in the center, one of which still retains its glass ball.

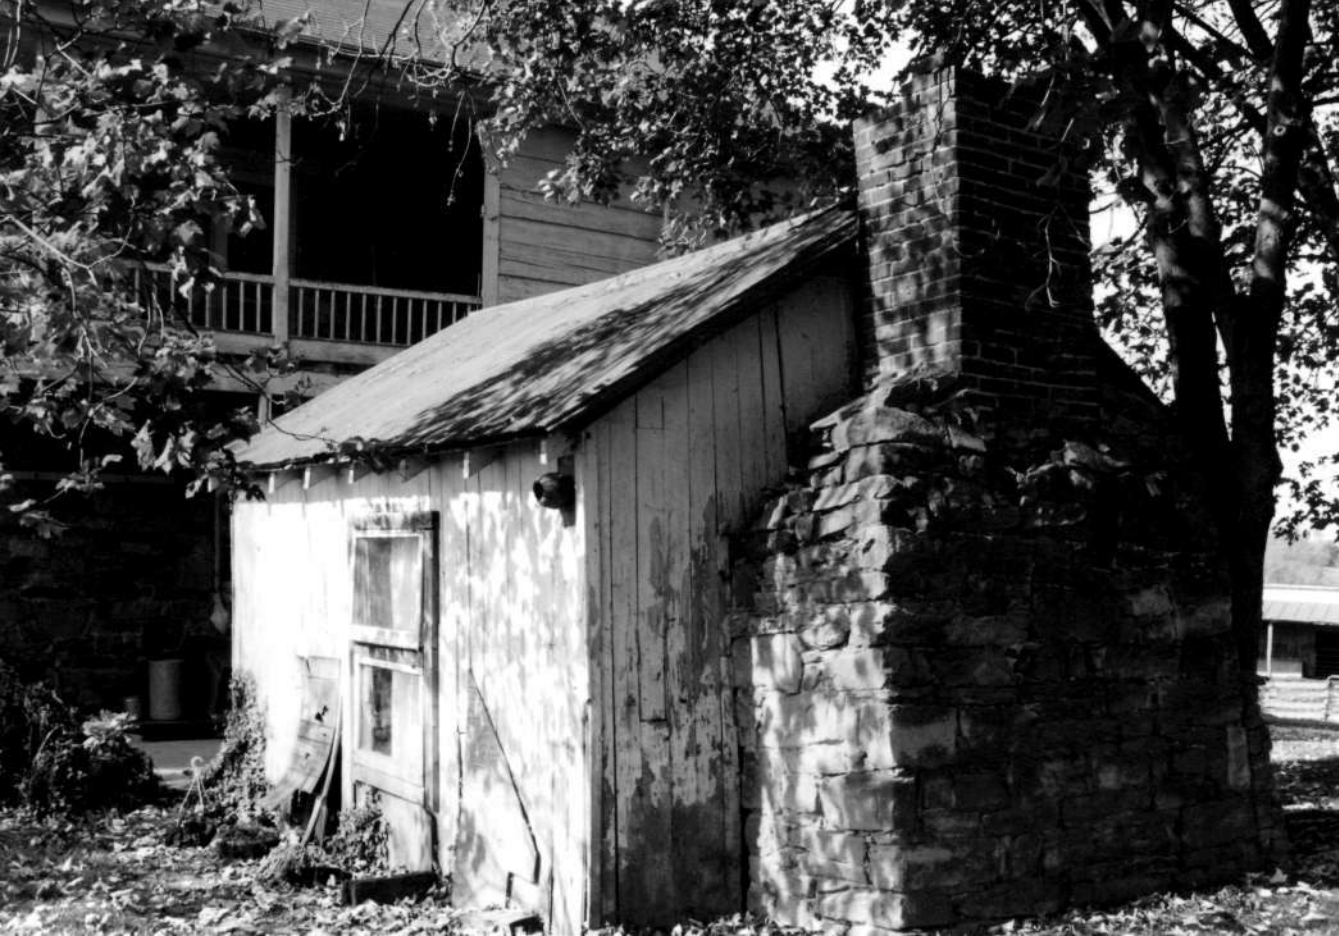
Neg Loc: Maryland Historic Trust
13/14

Summer Kitchen
S & E Elevation

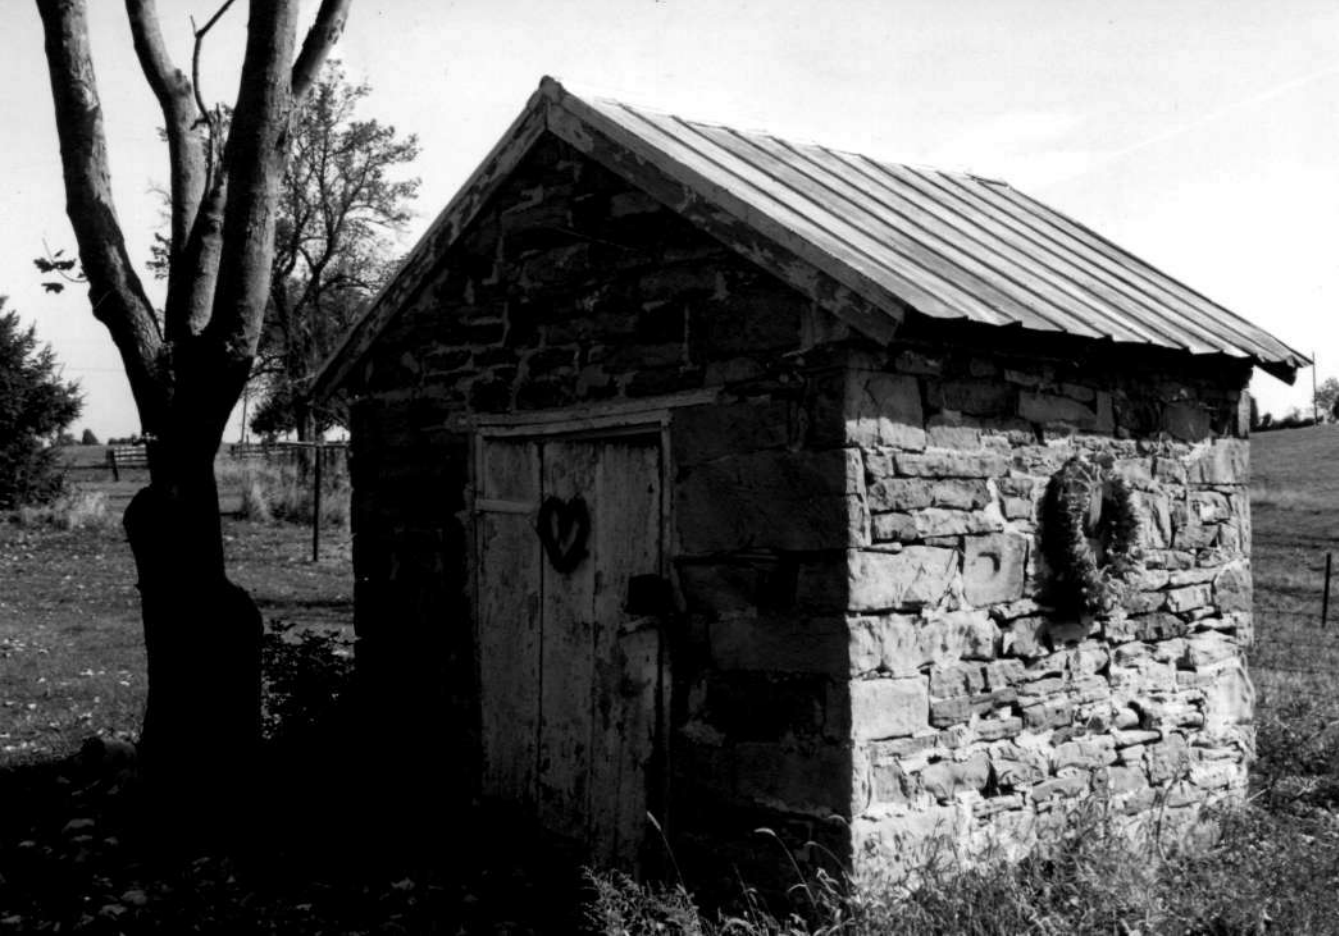
12/16

Jacob Koons Farm
11151 Otterdale Mill Rd
Smokehouse

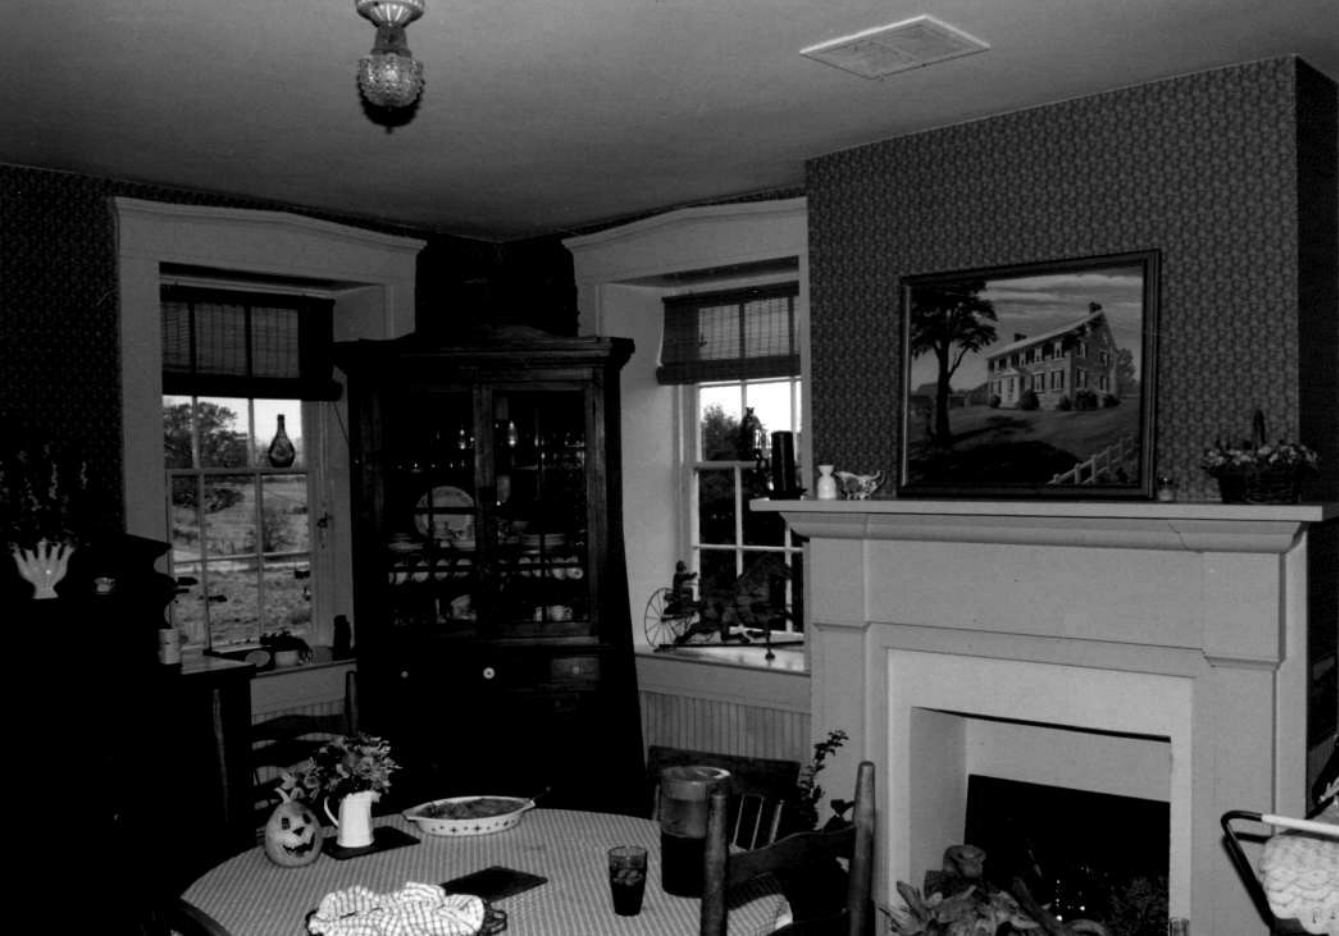
10/16

Jacob Hoorn Farm
1151 Otterdale Mill Rd
House - NW RM
VW NW

The northwest room has a random width pine floor of boards that are 5 to 7 inches wide and run north-south. The baseboards are identical to those in the passage. The door and window architraves on the south, west, and north elevations have a broken field. The top section of architrave is not mitered at the comers but is carried all the way across. The top edge of this architrave has a pedimented cornice moulding that consists of a fillet and a Greek cavetto. The window sash have parting beads and spring latches. The lights are 10 inches x 14 inches, the window jambs are splayed, and beneath the window sills is a board with a broken field. There is a fireplace centered on the north elevation that has a brick hearth and straight, plastered jambs. There is a wood mantel with pilasters that have cavetto moulds. The mantel has a plain frieze with a double ovolo bedmould. On the east elevation is a doorway that must be a later addition. It has plain architrave and the cornice has a fillet and Greek ogee mould. The cornice is not pedimented. The door for this opening is now in storage.

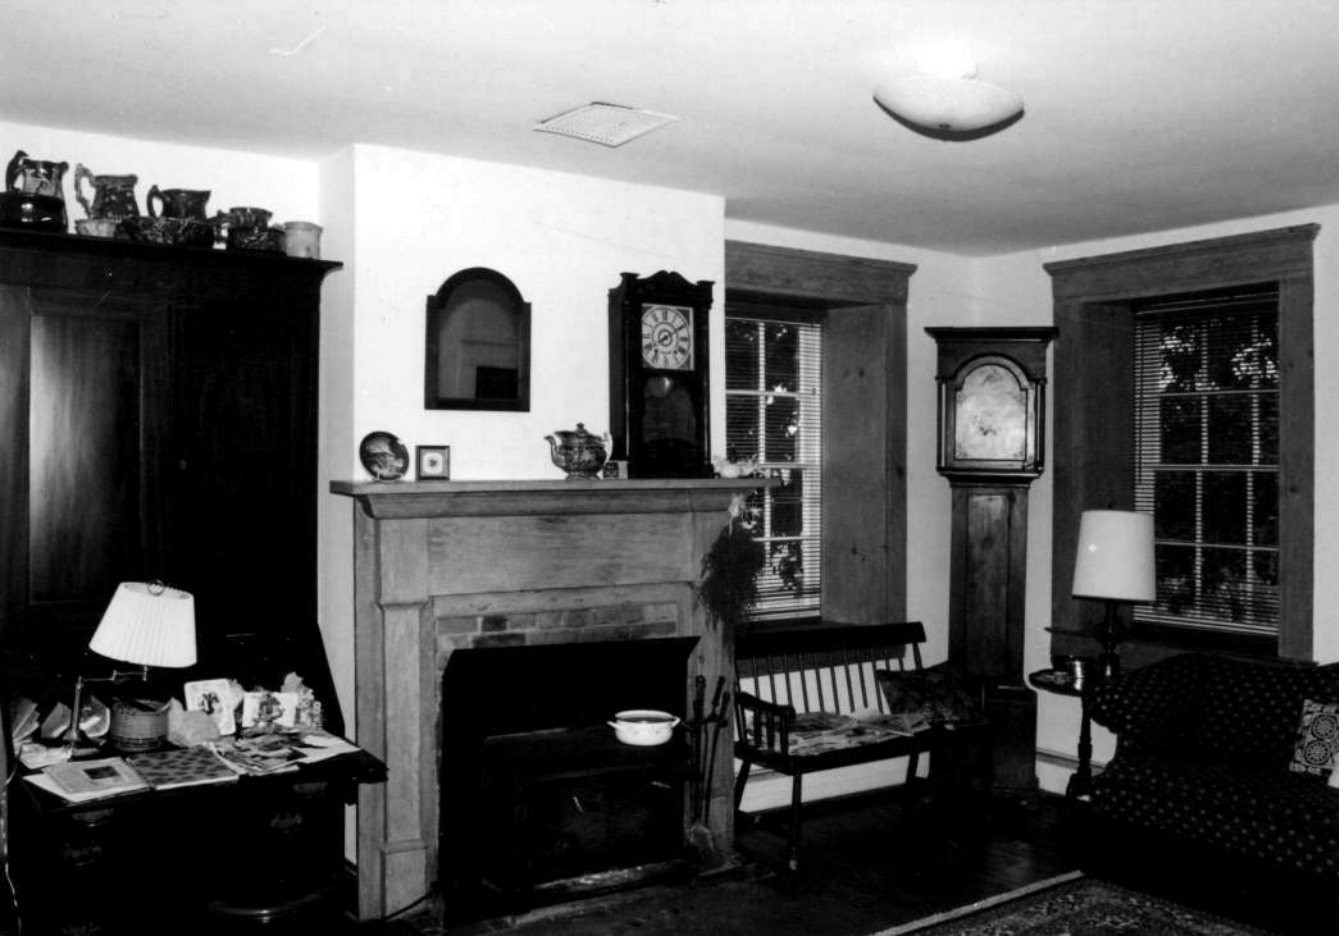
Jacob Koors Farm
1151 Otterdale Mill Rd
House - SW Room
NW - SW

The southwest room has the same flooring and baseboard as the northwest room. The window and door architrave have a broken field, and again the top architrave inner field is not mitered but runs all the way across the length of the architrave. This top piece also has a cornice with a fillet and a Greek cavetto, but it is not pedimented. The window jambs are splayed, the windows have parting beads and spring latches, and again there is a broken field beneath the sill. There is a fireplace on the south elevation that is now enclosed for a wood stove. There is a wood mantel with pilasters that have ogee capitals. The mantel has a plain frieze and a bedmould with a Greek ogee above a large ovolo. The west elevation of the fireplace has a small wood door with beaded-interior-edge mitred architrave. The door is hung on plain cast iron butt hinges. The fireplace has a brick hearth. South of the fireplace there was a door and transom leading to the exterior. This door and transom were moved to the northeast room and the opening was closed off in the interior by the present owners. The opening had already been enclosed with stone on the exterior at an earlier date, rendering the doorway nonfunctional. The southeast corner has part of the flue from the cellar fireplace projecting into the room. There is a door on the east elevation leading to the southeast room. It has a typical four-panel arrangement found in this house and has panel moulds on the southwest room side only. It is hung on plain cast iron butt hinges, has a cast iron rim lock marked "PATENTED MAY 5th 1863. JUNE 7th 1864", and has a porcelain knob. There is a doorway on the north elevation, at the east corner of the room, that leads to the northeast room. It, too, is of a typical four-panel arrangement with panel moulds on the southwest room side only. The door is hung on plain cast iron butt hinges, has a cast iron rim lock marked "M.W. & CO. NEW HAVEN", and has a mineral knob.
